## Aquatic Invasive Species Inspection Report

Lake: Island (**DOW# 58006200**)

Minnesota DNR Aquatic Invasive Species program staff inspected Island Lake for Eurasian watermilfoil (EWM) on 07/22/2026. Eurasian watermilfoil was documented at numerous sites around the lake. A large batch was documented in the area around the public boat access. Management activities should be considered in 2026.

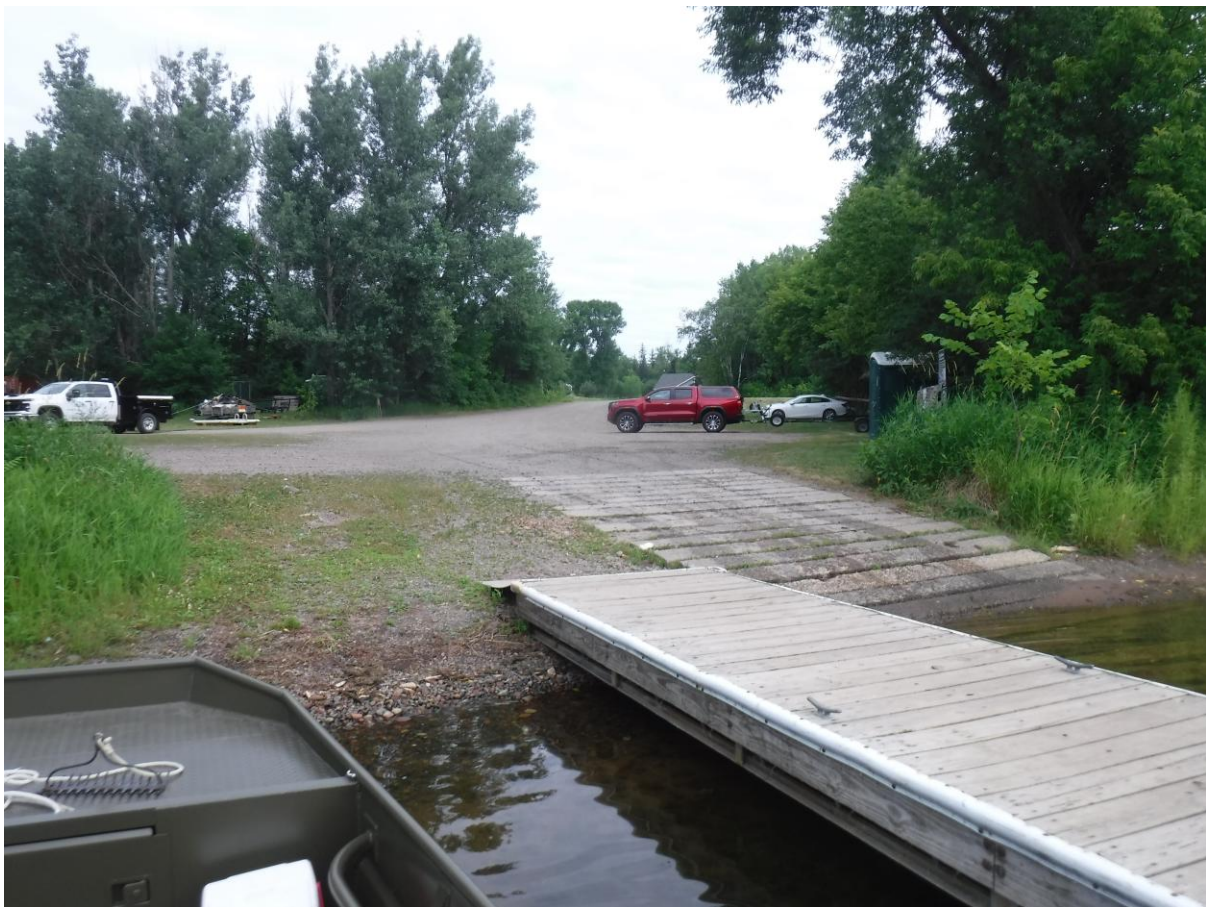
**Photo 1: A view of the boat ramp on Island Lake from 23 July 2026.**

Eurasian watermilfoil was not difficult to find on 22 July (figure 2). Numerous small spots of EWM were documented around the lake. None were particularly dense but could be considered for management in 2026. No heavy growth of EWM was documented during the survey except around, and to the east, of the public access where a dense band of EWM was documented (Site 1). Eurasian watermilfoil has expanded in density and acreage there since the survey in 2025. Strong consideration should be given to management activities to control further spread of EWM from Site 1.

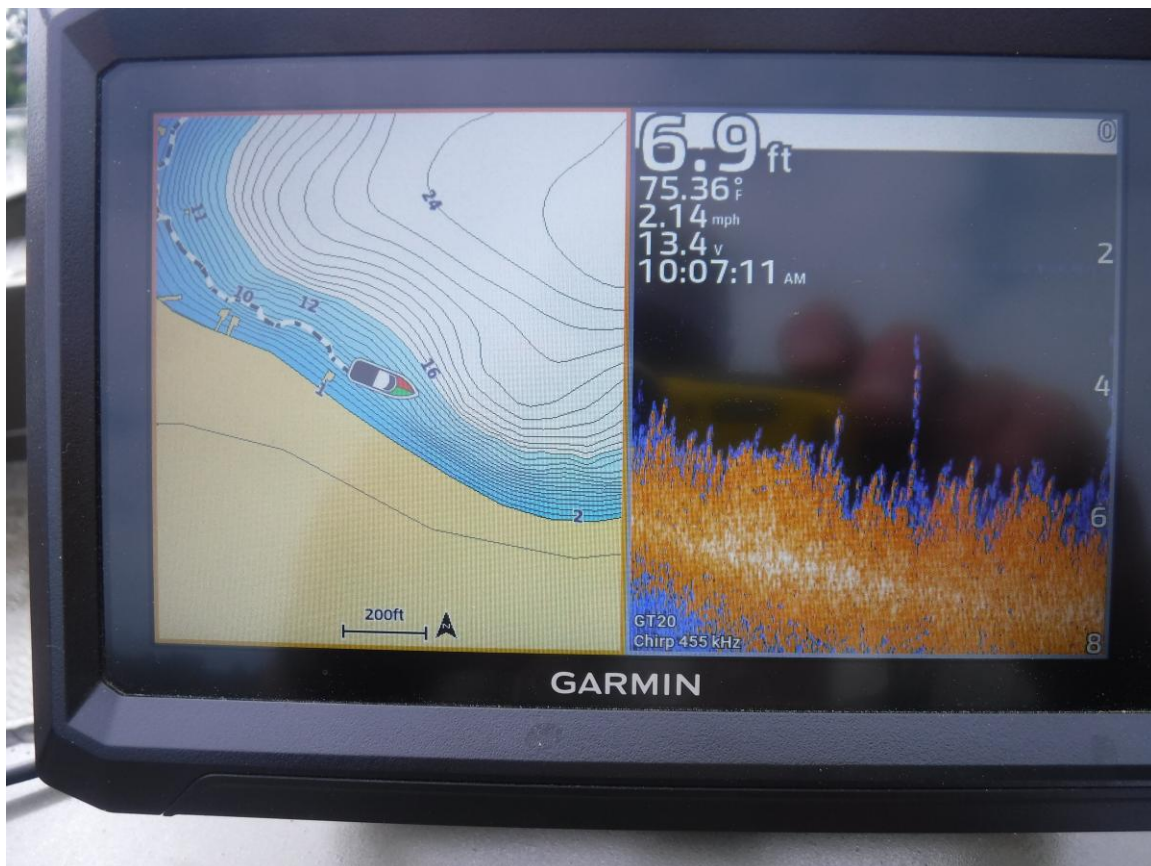
The survey was done from a boat with a sampling rake, water depth was measured with the depth finder, and GPS coordinates were recorded on a Garmin Map62stc unit. Sonar aided in the search for EWM as shown in photo 2.

**Photo 2: Down-scan sonar image from Island Lake on 22 July 2026.**

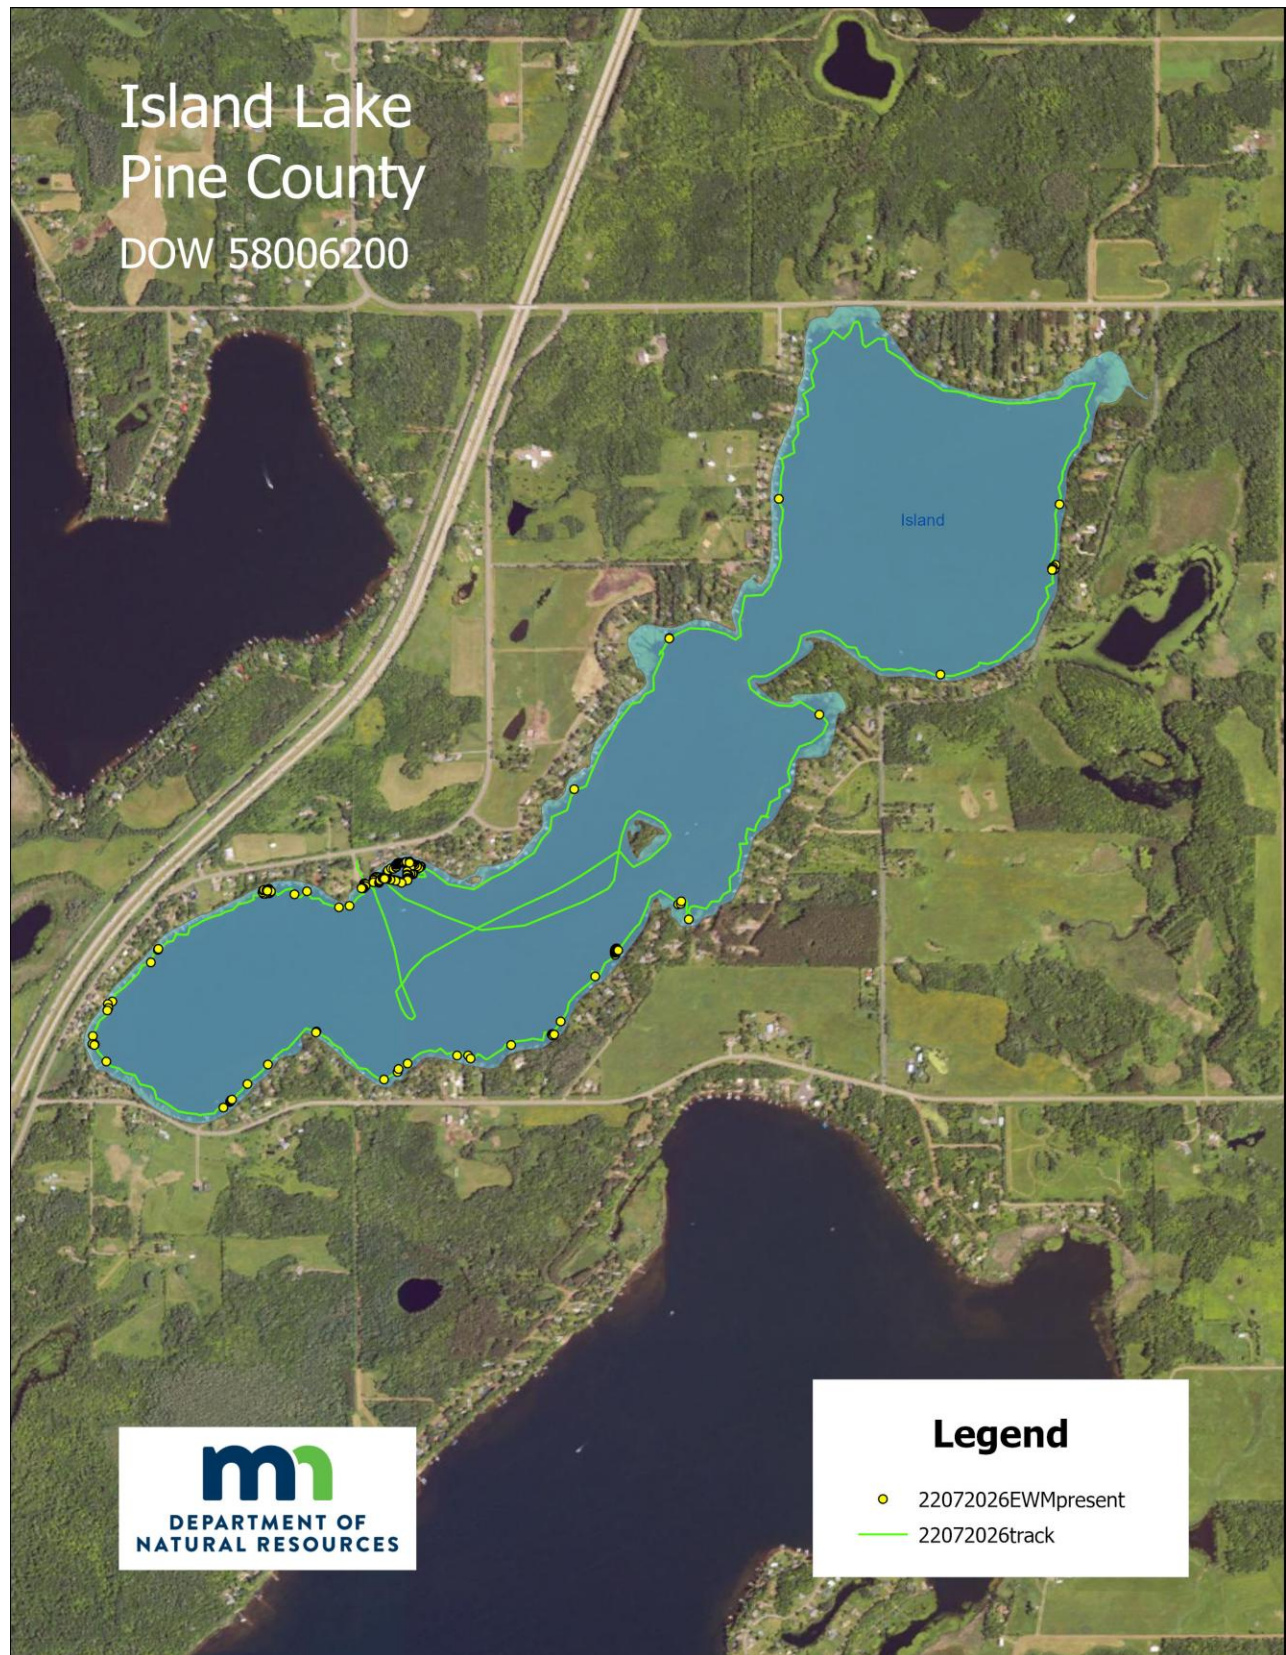
Delineation methods involved both visual methods and the use of a two-sided plant rake. The boat was driven around the littoral zone of Island Lake with intermittent meandering (figure 1). Special attention was paid to areas in the lake where favorable EWM growing conditions were present.

Figure 1. A survey map of Island Lake showing EWM locations in yellow and survey tracks in green from 22 July 2026.

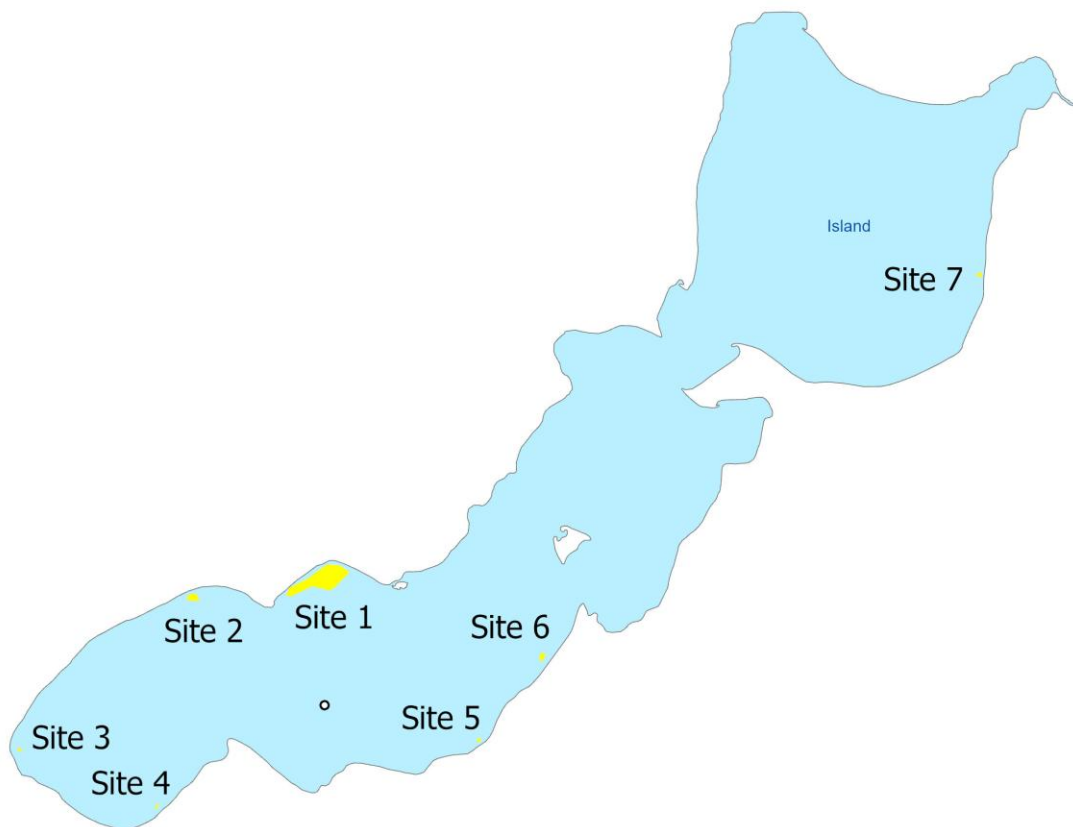
Figure 2. A map showing proposed EWM management areas on Island Lake for the 2026 season.

| Site | Acres | Observations | Treatment recommendation |
|---|---|---|---|
| 1 | 1.63 | Dense, widespread EWM at surface | treatment in 2026 |
| 2 | 0.09 | 30 to 50 stems wide spaced | treatment in 2026 |
| 3 | 0.001 | 5 to 10 stems | consider treatment in 2026 |
| 4 | 0.001 | 20 to 30 stems in a narrow strip | consider treatment in 2026 |
| 5 | 0.01 | 20 to 30 stems | consider treatment in 2026 |
| 6 | 0.03 | 20 to 30 stems | consider treatment in 2026 |
| 7 | 0.01 | 5 to 10 stems | |

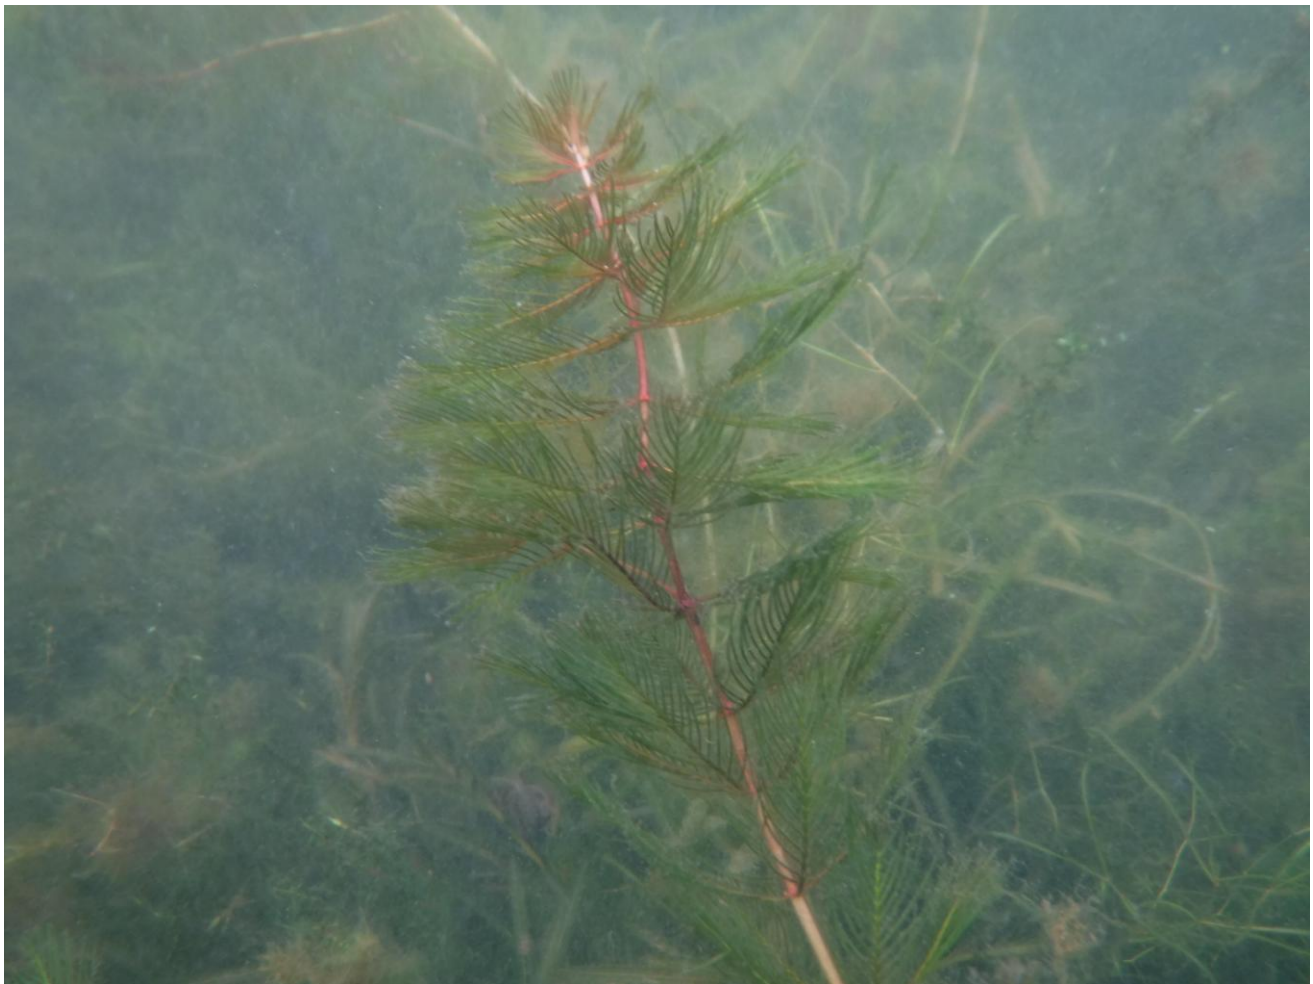
**Photo 3. A stem of EWM from island Lake on 22 July 2026**
